Restoring habitat for fish, wildlife & our community

Why did Morse Creek need a makeover?

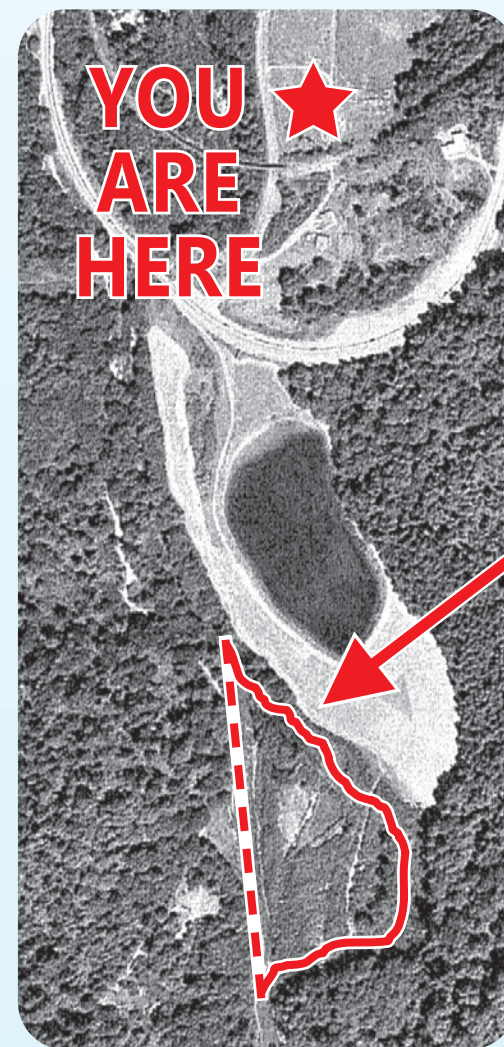
FLOOD PLAIN

- Straightened Channel
- Realigned Channel
- Pools for salmon
- ⌘ Engineered log jams (ELJs)
- Channels activated at high water only
- ↑ Downstream

1,200 FEET

1,900 FEET

flows to the Strait of Juan de Fuca

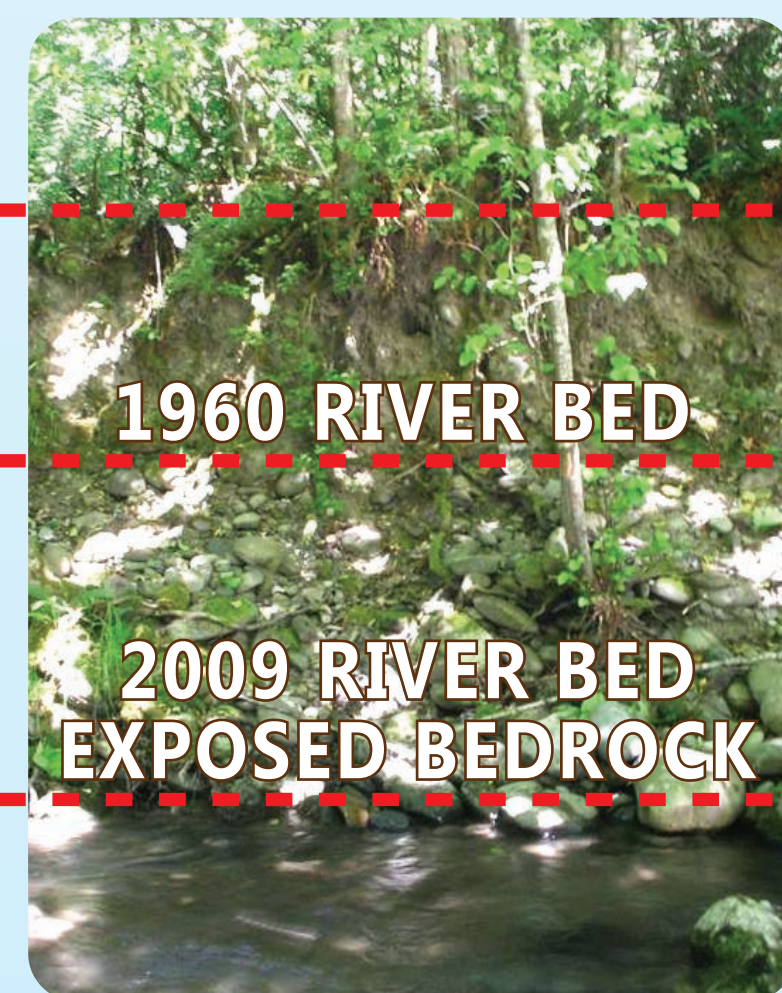
In 50 years, up to 8 feet of river bed was washed away!

Dike constructed in early 1960s to contain the straightened channel.

River gravels lost between 1960 and 2010.

Bedrock 2010 river bed

In the 1960s a 1,900-foot meander of the Morse Creek channel was straightened and confined into 1,200 feet, causing higher water velocity.

Salmon need pockets of slow moving water to rest, gravel for spawning, and logs to hide under - unnaturally high water velocities in the straightened Morse Creek channel stripped these habitat elements away, leaving bedrock.

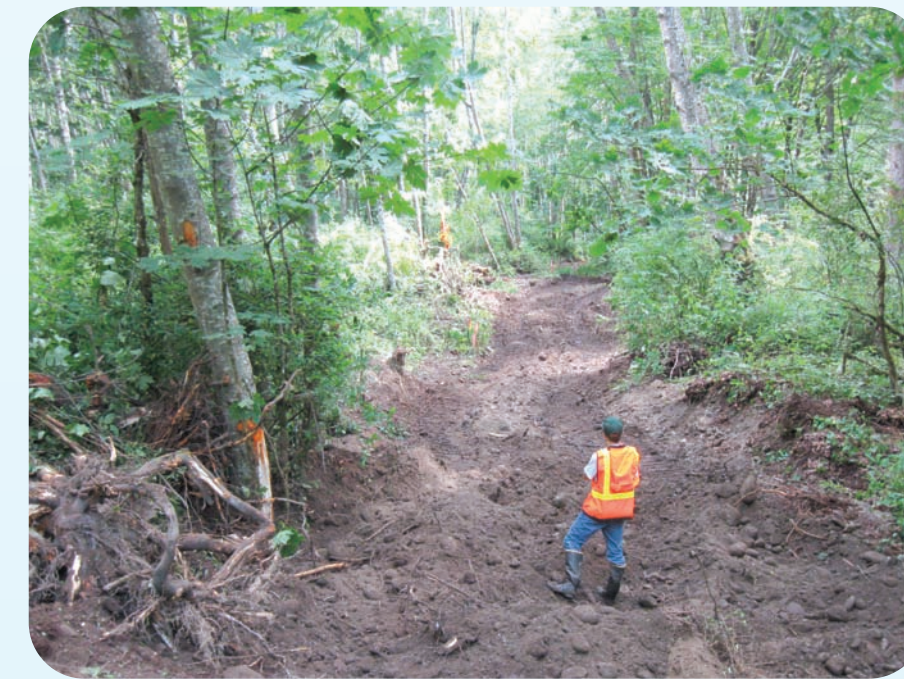
The 2002 purchase of the parcel for conservation was the first step in moving Morse Creek back into its historic channel. The channel was overgrown, but its river gravels were found underneath the young forest.

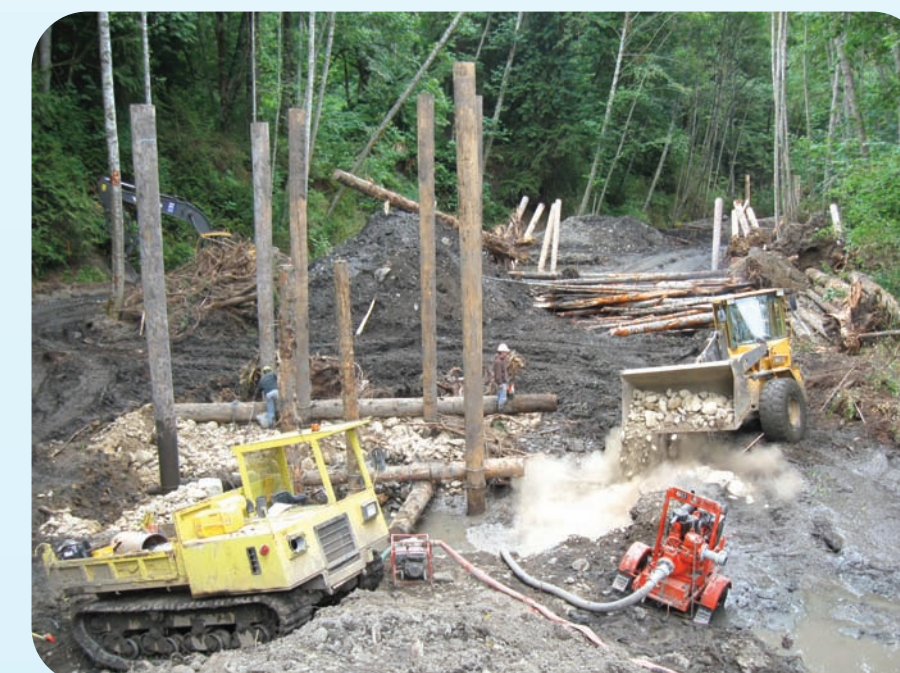
The historic channel was cleared and 19 engineered log jams (ELJs) were installed to divert the water back to its old path and to help stabilize the 1,900 feet of newly constructed channel.

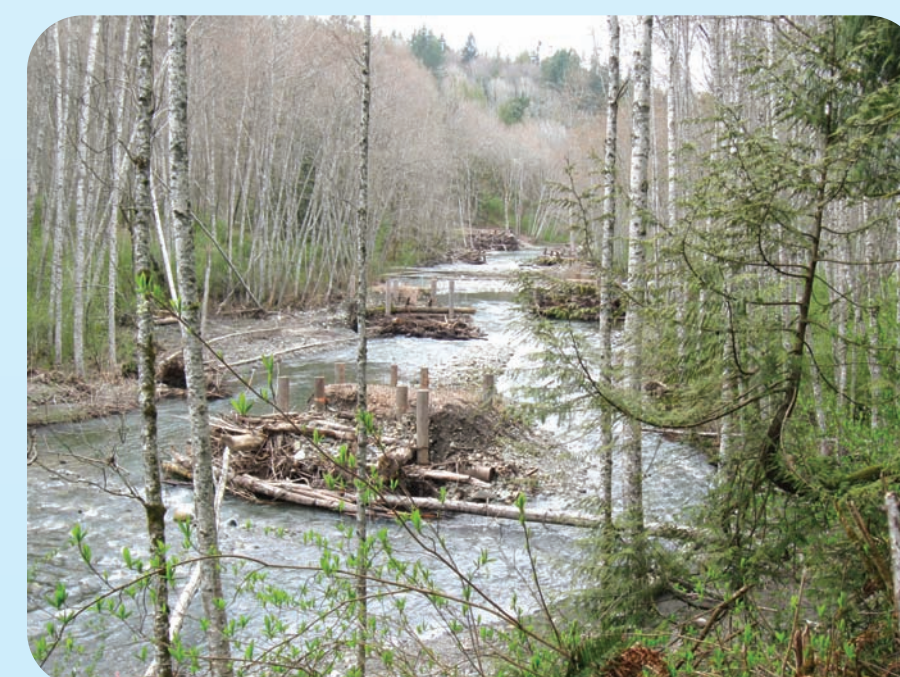
River flows dig pools at ELJ's upstream ends and have eddies that build riffles at their downstream ends. The pools are deep, quiet resting, hiding, and feeding areas. The riffles serve as salmon spawning areas. The ELJs catch and hold wood washing downstream, adding habitat diversity through the years.

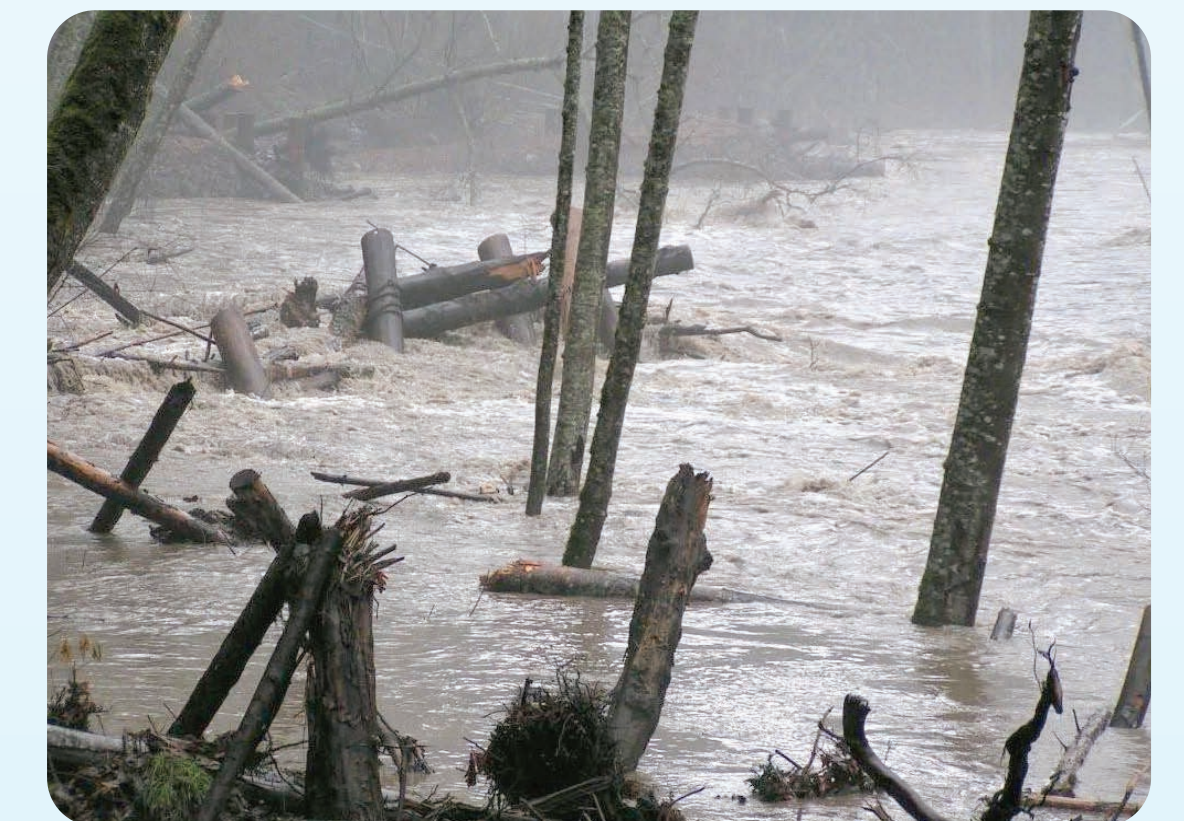
During the winter floods, the newly constructed channel allowed the river to spread out into the forested floodplain. Here waters slow and juvenile salmon seek refuge and feed.

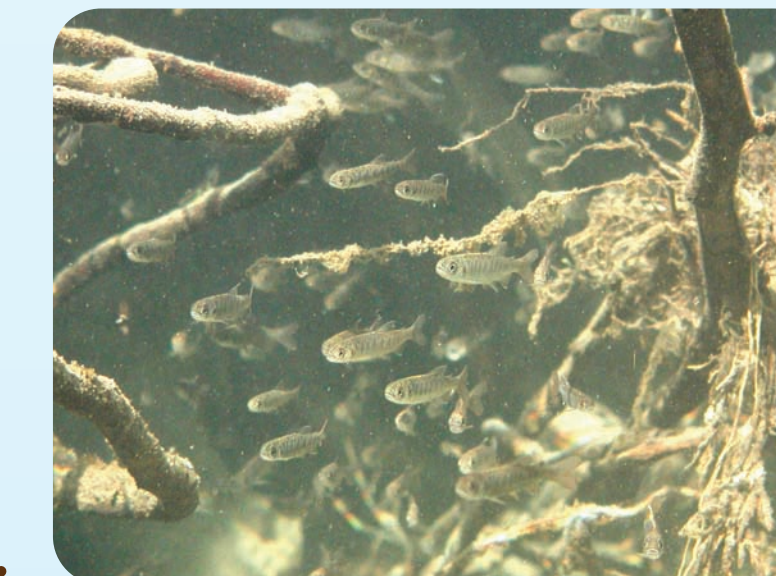
Fish monitoring shows that adult salmon are actively spawning in the new riffles.

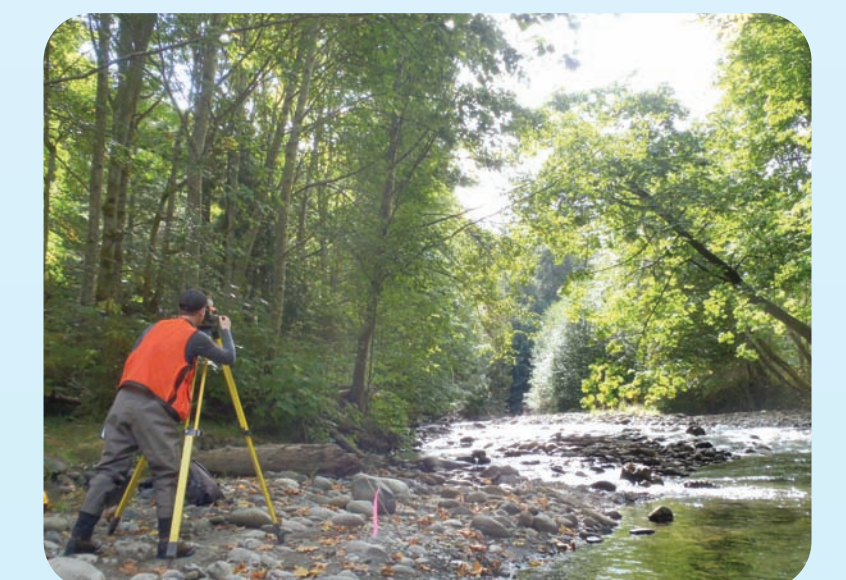
Habitat surveys indicate a two fold increase in favored pools and a complete removal of rapids that are poor habitat for fish.
